TECHNICAL NOTE

No. 1235

AN INVESTIGATION OF A THERMAL ICE-PREVENTION SYSTEM FOR A  
CARGO AIRPLANE. VIII - METALLURGICAL EXAMINATION OF THE  
WING LEADING-EDGE STRUCTURE AFTER 225 HOURS OF FLIGHT  
OPERATION OF THE THERMAL SYSTEM

By Maxwell Harris and Bernard A. Schlaff

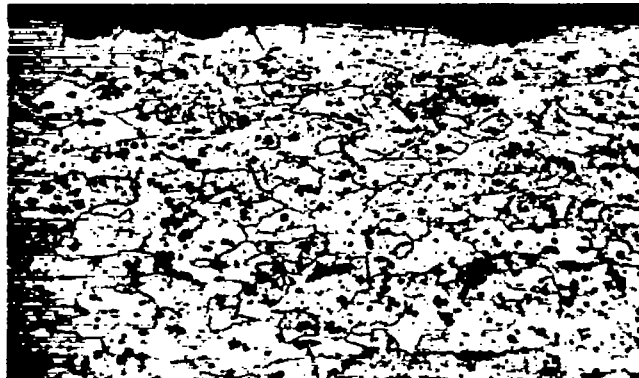
Figure 5.- Cross section of baffle-plate cladding and core beneath the synthetic rubber particle at section A-A, figure 3. Magnification, 200X; Keller's etch. Pitting is severe but has not penetrated the cladding.

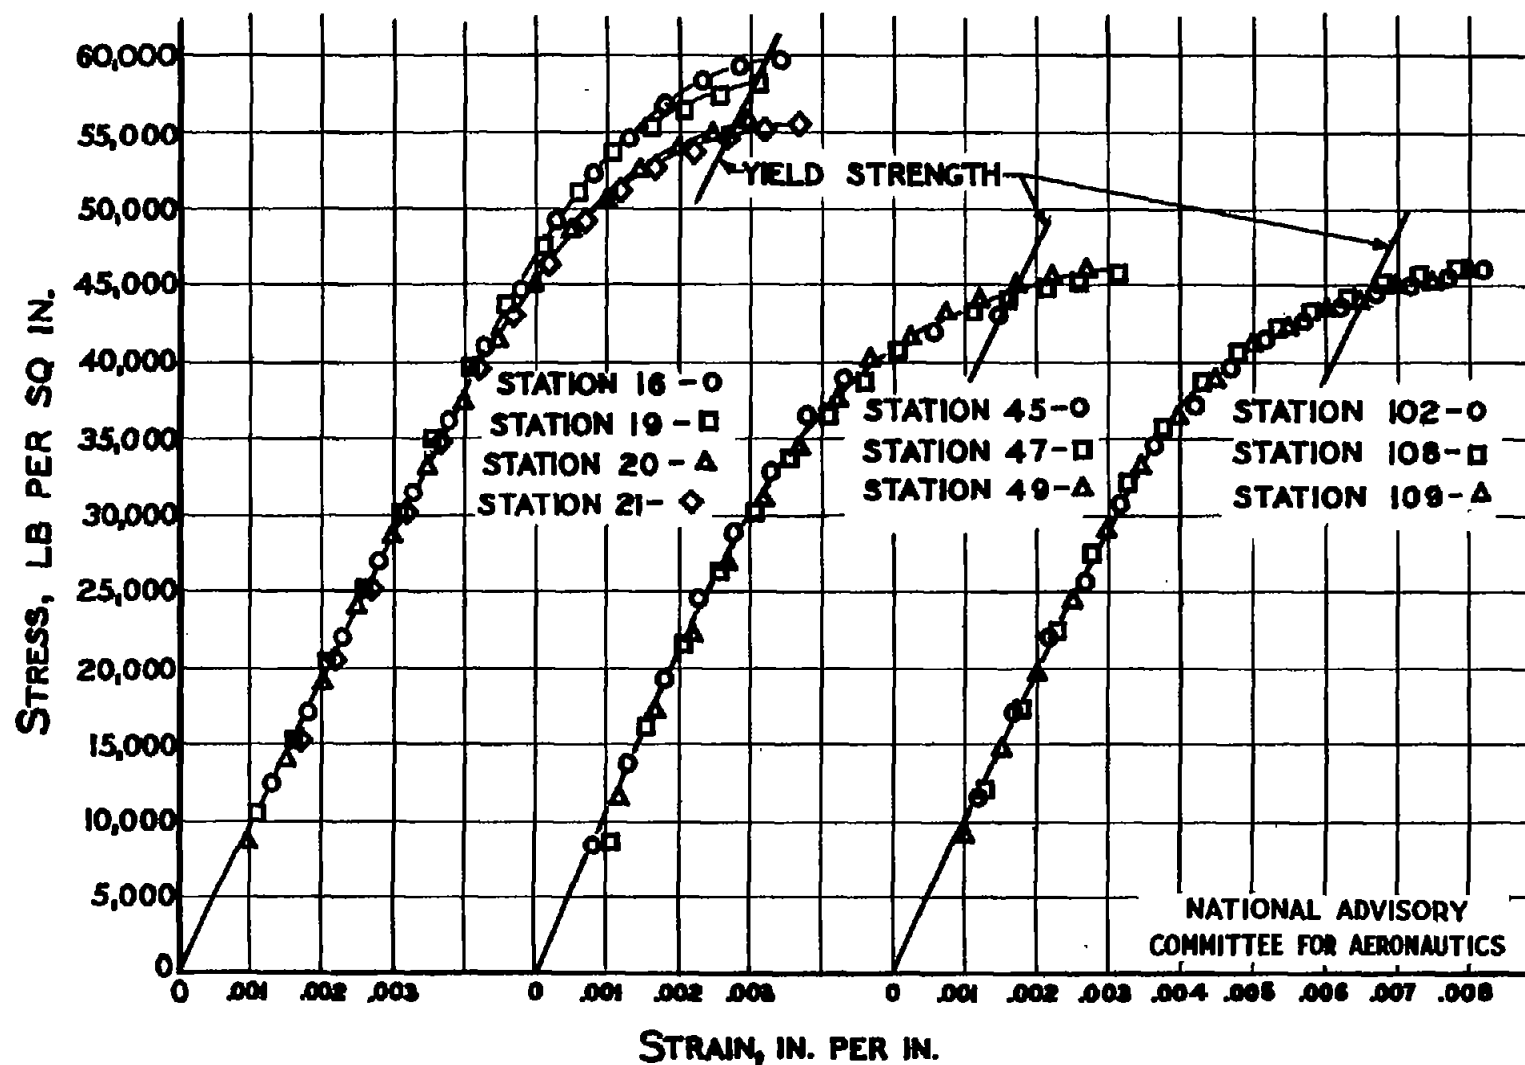
It may be noted in table I that from station 16 to 21, a distance of only 5 inches, there is a continuous decrease in yield strength and an attendant gain in elongation, approaching room-temperature values. This indicates an effective differential in temperature, even over this short distance, substantiating investigations (reference 3) on the artificial aging of Alclad 24S-T which have revealed that in a critical temperature range of from 300° F to 375° F small differences in temperature may cause quite noticeable changes in yield strength. The values obtained for the ultimate tensile strength and yield strength for the specimens from stations 45, 47, 49, 102, 108, and 109 do not indicate any marked temperature-aging effect as they compare closely with the figures given in reference 15. The stress-strain curve for each specimen is shown in figure 12. This figure shows clearly the

increased ultimate and yield strengths of the specimens from stations 16 to 21 resulting from artificial aging. The yield at 0.2-percent offset is indicated by the short intercept line at the knee of each curve. Essentially, the modulus of elasticity is the same for all curves, which is normal for room-temperature tensile tests of this material.

FIGURE 12- STRESS-STRAIN CURVES FOR ALCLAD 24S-T ALUMINUM ALLOY  
TEST SPECIMENS TAKEN FROM THE BAFFLE PLATE OF A THERMAL ICE-  
PREVENTION SYSTEM INSTALLED IN A C-46 AIRPLANE WING.
